Navajo Abandoned Uranium Mine

Site Screen Report

Mine Name: Sam Charlie No. 1
Mine ID: 244

April 2012

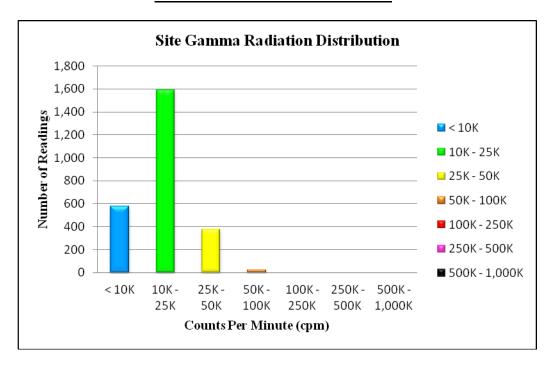
Highest gamma radiation measurement: 64,504 counts per minute (cpm)

A total of 2,564 gamma radiation measurements were collected from the mine site, ranging from 5,590 cpm to 64,504 cpm. Maximum levels of approximately 60,000 cpm were found in the vicinity of the waste rock and 30,000 cpm were found in the tailings area. The measurements are represented in Figures 1 and 2.
